# GREEN AUDIT

STUDY PERIOD (ONE YEAR) 2023 - 2024

## AUDIT REPORT

**Cummins College of  
Engineering for Women**

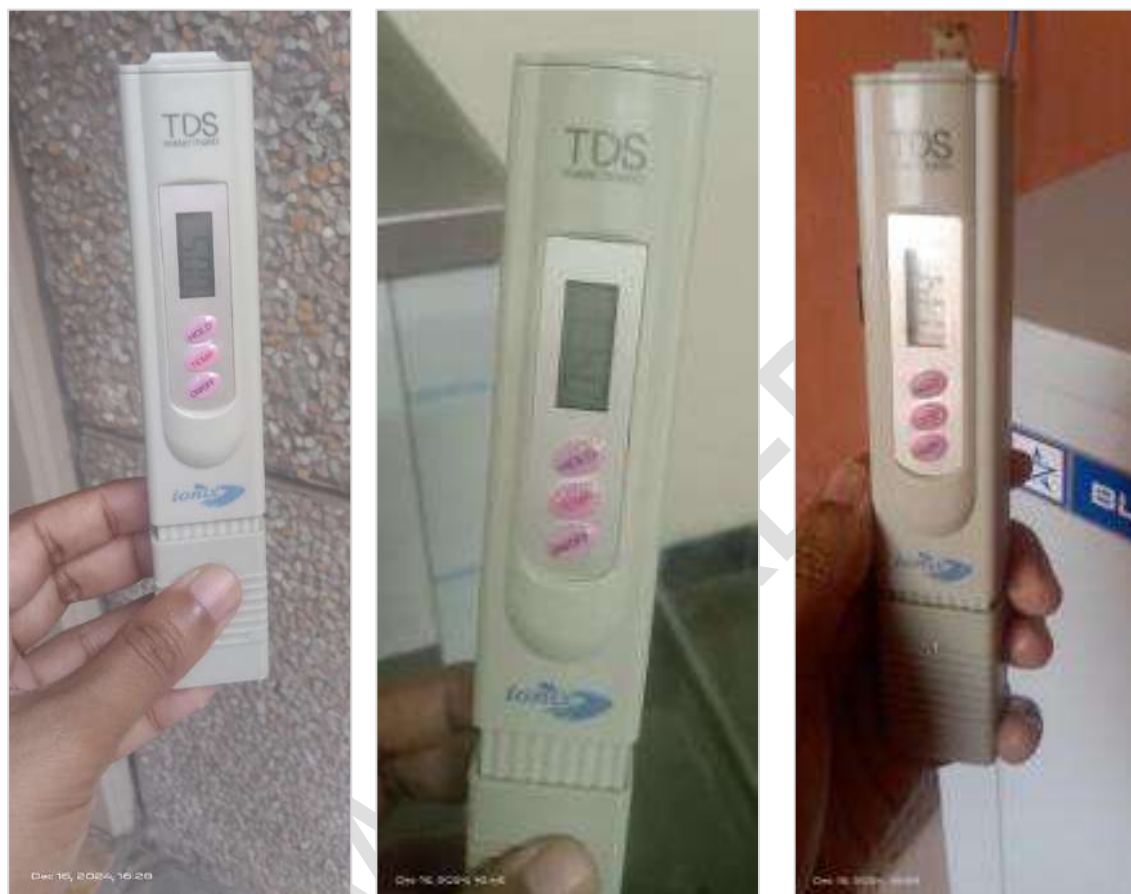
*Figure 1: Water testing investigation study of all water coolers*

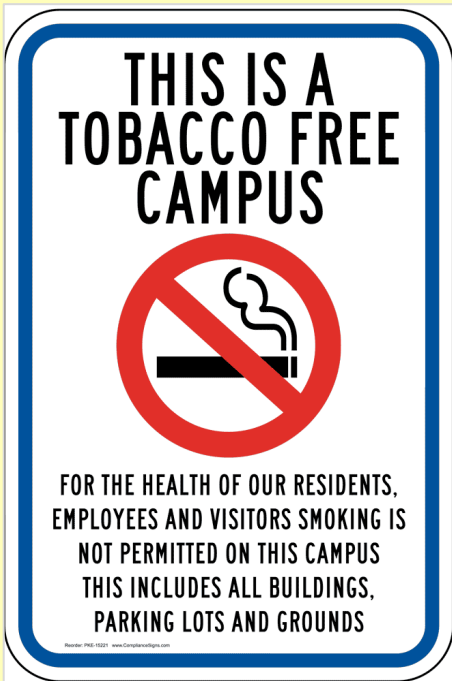
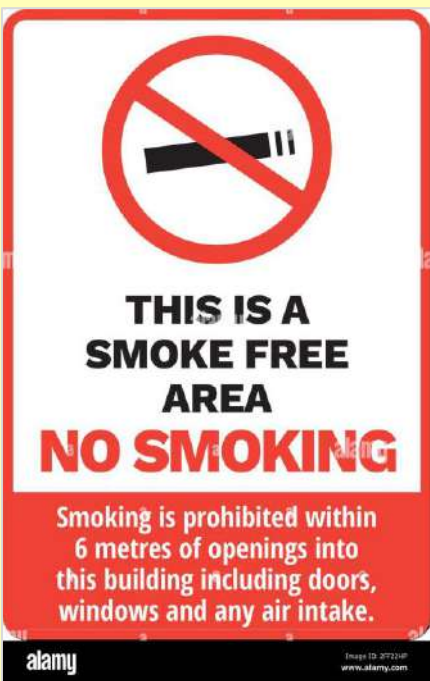
| 5. | <p>Health &amp; Hygiene aspect</p> <p><b>Aspect area:</b></p> <p><b>Zone demarcation through signages</b></p> | <p>Introduce zone boards (Optional through mention of state/ central govt. acts) at entrance of the premises in an enlarged A1 poster</p> <div style="display: flex; justify-content: space-around; align-items: center;"> </div> <p style="text-align: center;"><i>Sample images for zones</i></p> <p>Image source: Compliance signs</p> |

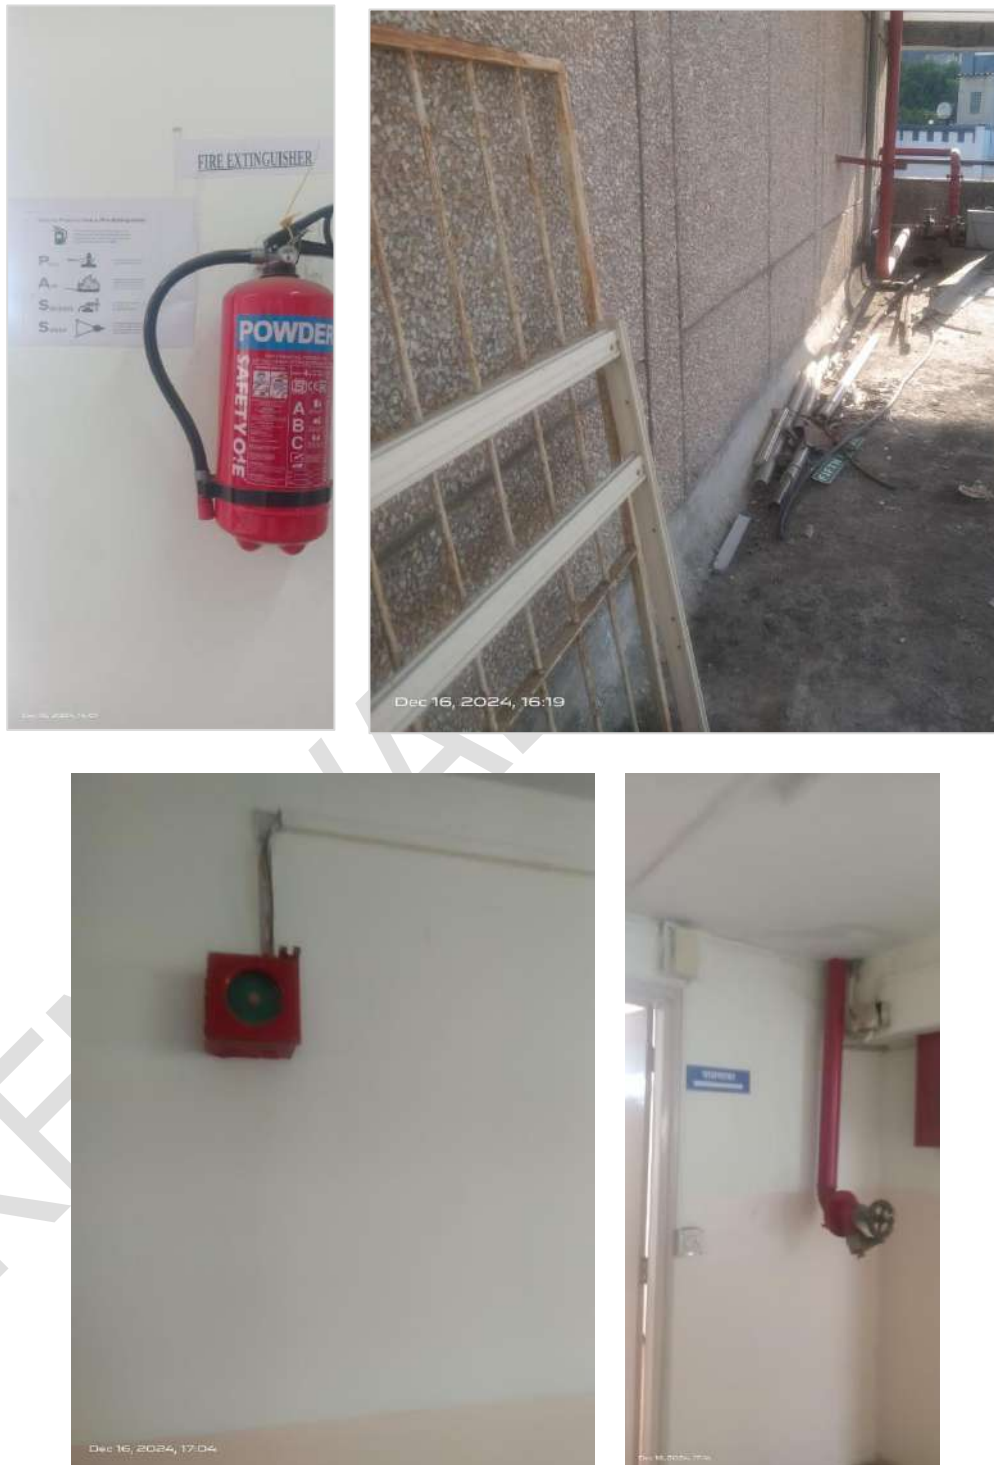
**Plate 5: Fire and life safety measures undertaken**

The facilities include fire extinguishers, PASS signage, fire alarm and fire hydrant.

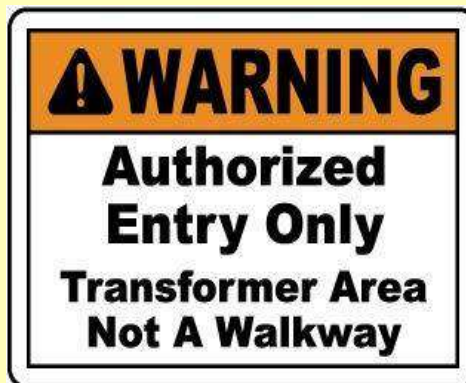
**Transformer/ Diesel generator /Meter room/ Electrical board**

**HAZARDOUS VOLTAGE  
INSIDE. CAN SHOCK,  
BURN, OR CAUSE DEATH.**

**Keep out.**

**If open or unlocked,  
immediately call  
electric power and  
light company.**

| 5. | <p>Energy generation aspect</p> <p><u>Aspect area:</u></p> <p><b>Danger areas</b></p> | <p>Signage about 'Danger zone' should be displayed and sand bucket/ fire ball should be placed nearby</p> <p><b>Battery storage area</b></p> <p>The image shows a yellow rectangular caution sign with a black border and the word 'CAUTION' in large, bold, black letters at the top. Below the title, there are three bullet points: 'THIS ROOM CONTAINS ENERGIZED BATTERY SYSTEMS', 'THIS ROOM CONTAINS ENERGIZED ELECTRICAL CIRCUITS', and 'THE BATTERY ELECTROLYTE SOLUTIONS ARE CORROSIVE LIQUIDS'. At the bottom of the sign, there are three circular diagrams illustrating different installation methods: 'For walls: Affix with screws (not included)', 'For posts: Affix with nuts &amp; bolts (not included)', and 'For fence or gate: Affix with zip ties (not included)'.</p> |

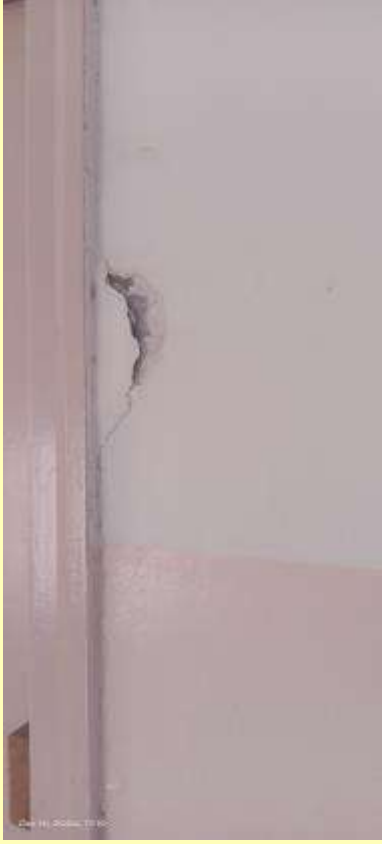
| 10. | <p>Structural safety aspect</p> <p><u>Aspect area:</u></p> <p><b>Cracks</b></p> | <p>Certain minor cracks were observed in the campus that can be renvovated accordingly.</p> |

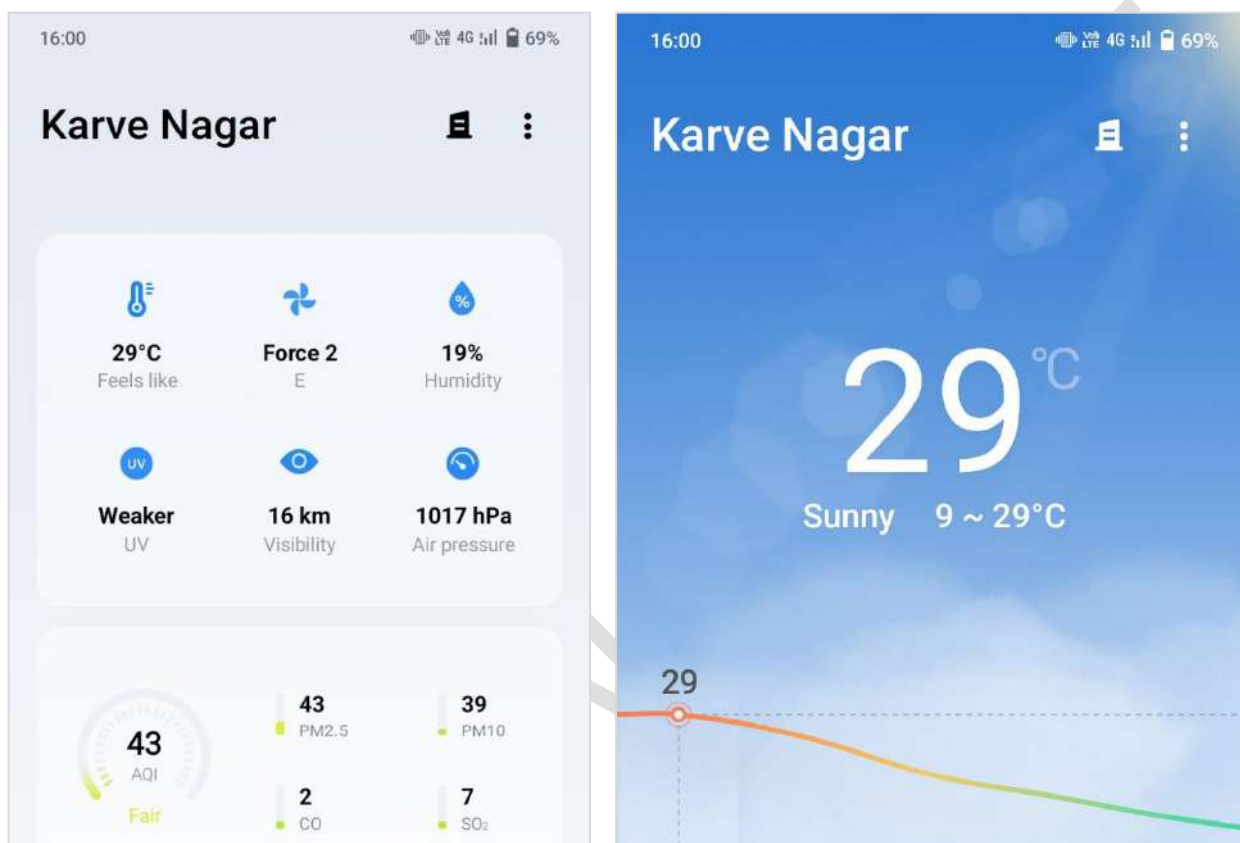
**Figure 1: Study at Mechanical building**

- ➡ Micro-climate temperature of site in (degree Celsius) – 29
- ➡ Particulate matter 2.5 micrometres or less in diameter (PM<sub>2.5</sub>) – 43
- ➡ Particulate matter 10 micrometres or less in diameter (PM<sub>10</sub>) – 39
- ➡ Carbon Monoxide (CO) – 2
- ➡ Sulphur dioxide (SO<sub>2</sub>) – 7
- ➡ **As per the application the AQI was 43 and found to be Fair**

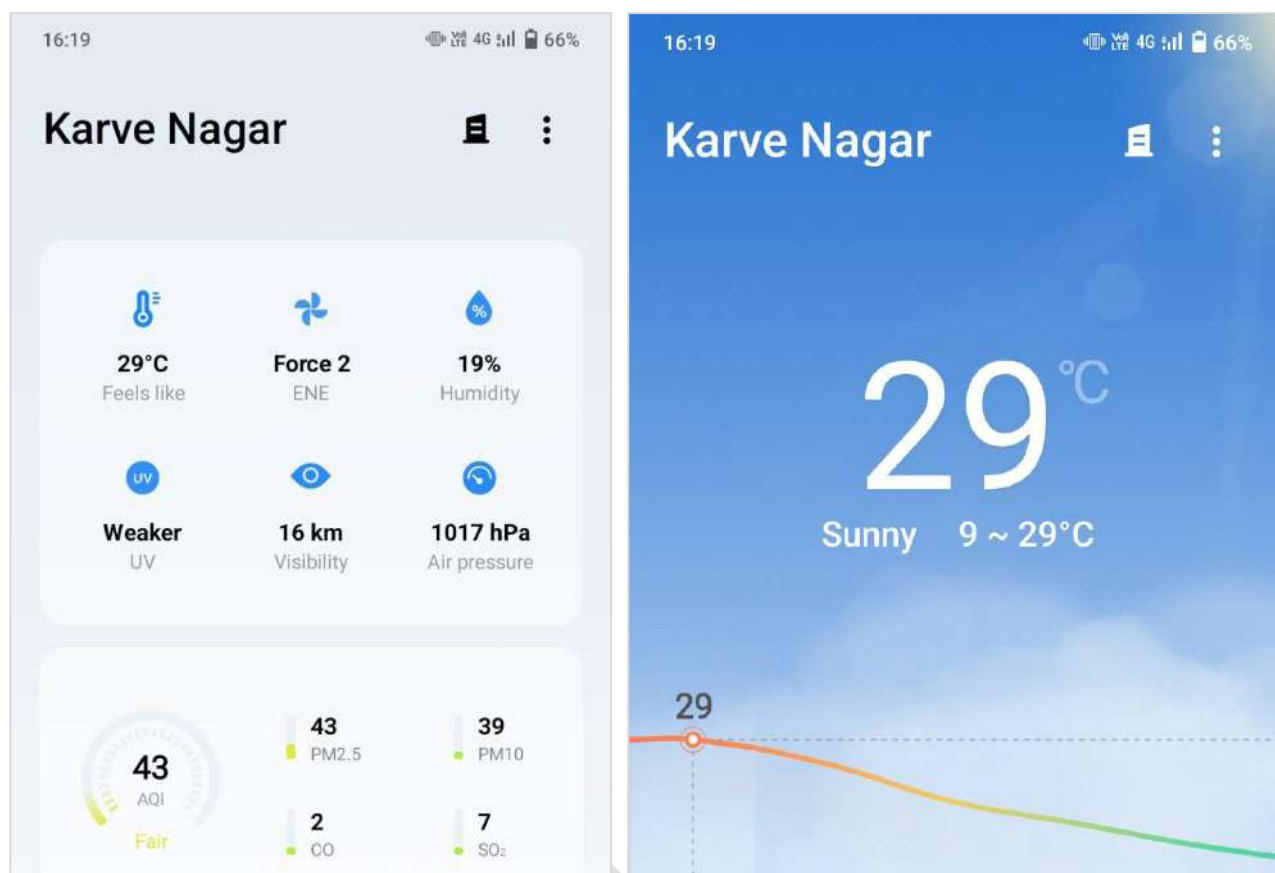
*Figure 2: Study at Terrace area of Mechanical building*

- ➔ Micro-climate temperature of site in (degree Celsius) – 29
- ➔ Particulate matter 2.5 micrometres or less in diameter (PM<sub>2.5</sub>) – 43
- ➔ Particulate matter 10 micrometres or less in diameter (PM<sub>10</sub>) – 39
- ➔ Carbon Monoxide (CO) – 2
- ➔ Sulphur dioxide (SO<sub>2</sub>) – 7
- ➔ **As per the application the AQI was 43 and found to be Fair**

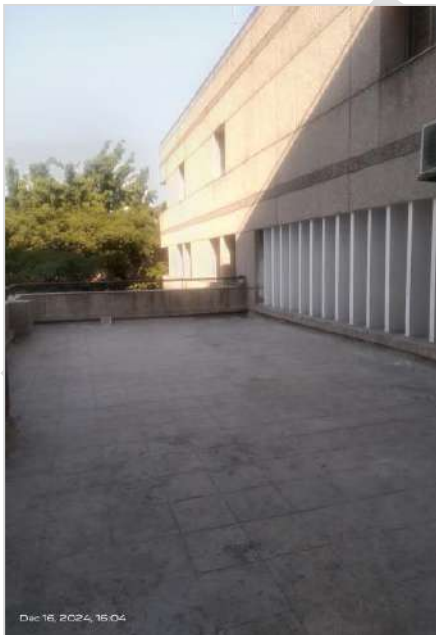
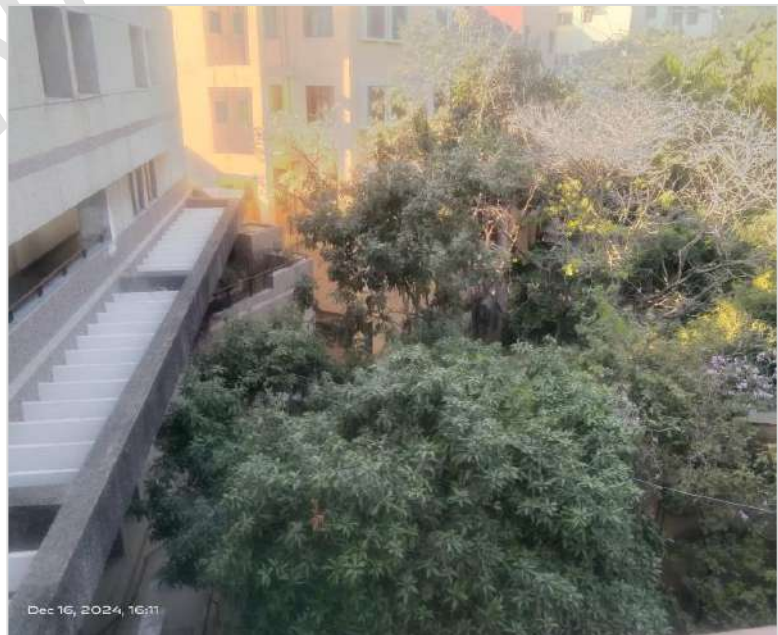
The heat island effect refers to the study of micro climatic feature within a site. There are multiple factors that add on to feature such as external temperature, internal temperatures, site context including available and site adjacent facilities. Observed features include:

- ➡ Light Colored Interiors
- ➡ Light Colored Exteriors
- ➡ Shaded Outdoor
- ➡ Shaded Walkways

**Plate 9: Elements related to heat island reduction**

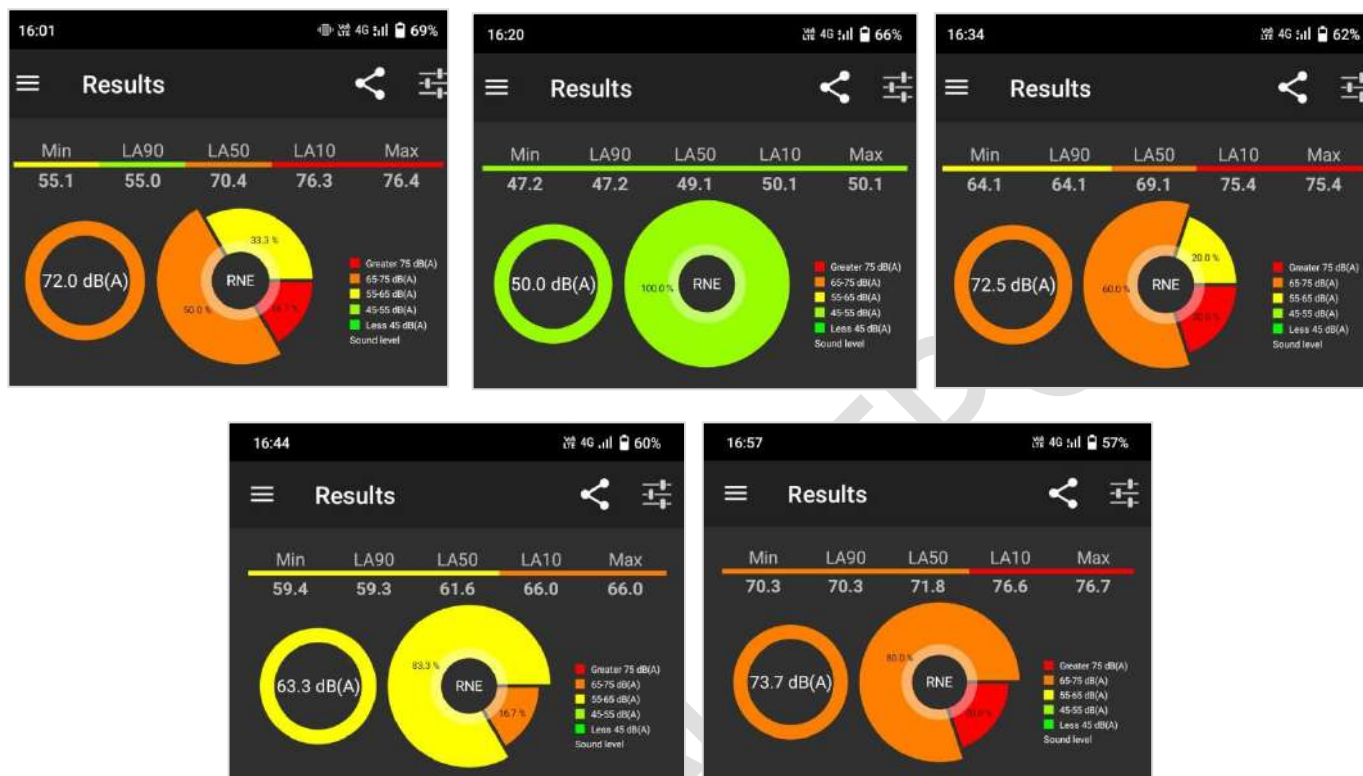
Figure 6: Noise levels at various times

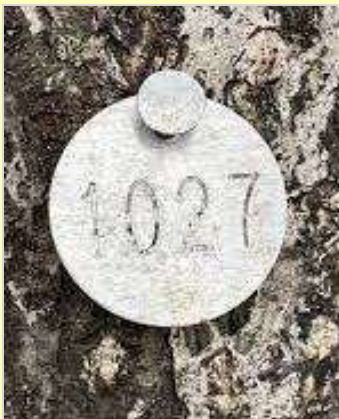
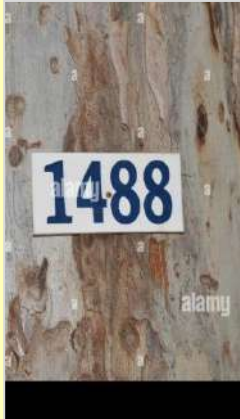
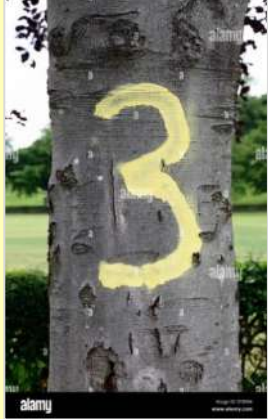
| S. No. | Aspect with evidence if any | Suggestion |
|---|---|---|
| 2. | Biodiversity aspect<br><u>Aspect area:</u><br><b>Numbering the plantations in the premises</b> | <p>Make a list of all the plantations in the premises and start numbering the plantations in either of the ways:</p> <ol style="list-style-type: none"> <li>1. Paint the nos. on iron plates and nail the same</li> <li>2. Print nos. on paper, laminate and paste the same</li> <li>3. Paint the nos. directly</li> </ol> <p>Sample image for 3 examples are noted below.</p> <div style="display: flex; justify-content: space-around;"> </div> <p><i>Options for numbering the plantations</i></p> <p>Care should be taken that the display should be visible.<br/> Uniform color palette should be identified and used.<br/> Measures should be taken to avoid withering during monsoon.<br/> This could be undertaken as a student activity.</p> |

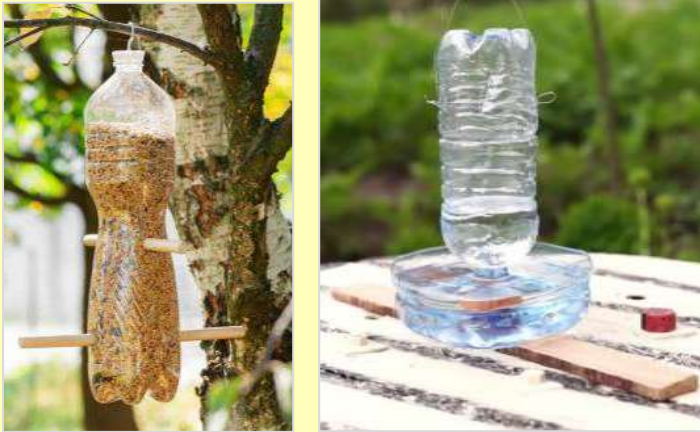
| | <b>feeders</b> | <p><i>Food and water feeder</i></p> <p>Waste plastic bottles can be recycled &amp; used as a student activity</p> |

| S. No. | Aspect with evidence if any | Suggestion |
|---|---|---|
| 3. | Biodiversity aspect<br><u>Aspect area:</u><br><b>Water and food</b> | At appropriate locations there can be provisions for drinking water and some grains for birds as they visit the site much frequently. |

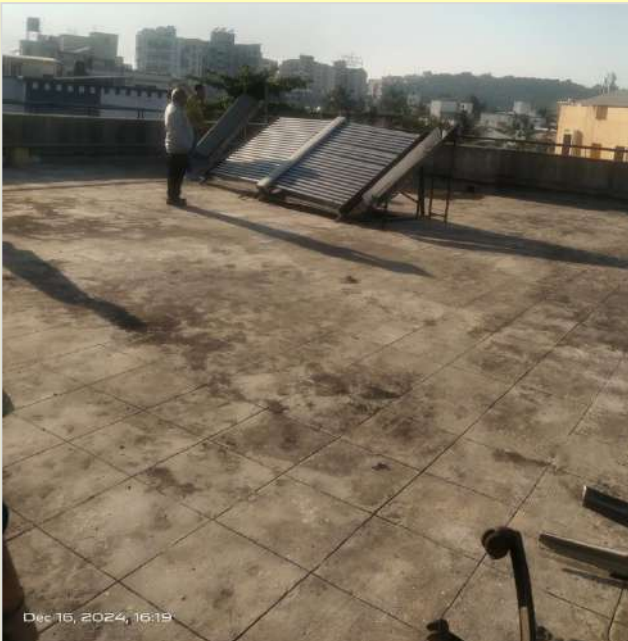
| 5. | Carbon footprint aspect<br><u>Aspect area:</u><br><b>Cool rooftop</b> | <ul style="list-style-type: none"> <li>➤ Keep terrace areas free of any kind of storage materials</li> <li>➤ Terrace rooftops can be painted with Cooltop (Reflective material) to reflect the harsh sun rays and reduce the heat absorption in the top most floor and surrounding areas of the building.</li> <li>➤ Introduce signboards about 'No students are allowed to enter'</li> <li>➤ Undertake feasibility study of before - after temperature reading.</li> </ul> <p>Current status for terrace</p> |

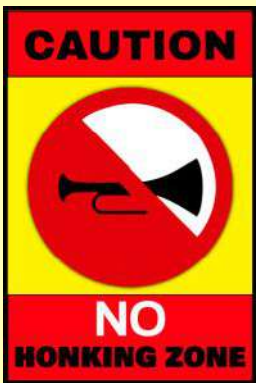
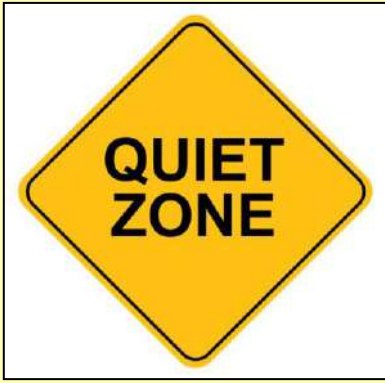
| 6. | <p>Noise aspect</p> <p><b>Aspect area:</b></p> <p><b>Demark &amp; display board about Silent zone</b></p> | <p>A signboard highlighting and 'No honking or Silent zone' should be displayed outside campus near all entrance gates; near roadside approach of site (Outdoor areas) and 'Quite zone' outside the library space (Indoor areas)</p> <div style="display: flex; justify-content: space-around; align-items: center;"> </div> |
